Instrumentation, Field Testing, and Fatigue Evaluation of Selected Approach Spans of the Throgs Neck Bridge (TN82) over the East River, New York

Final Report

Prepared for
Parsons
TBTA

ATLSS Report No. 06-17

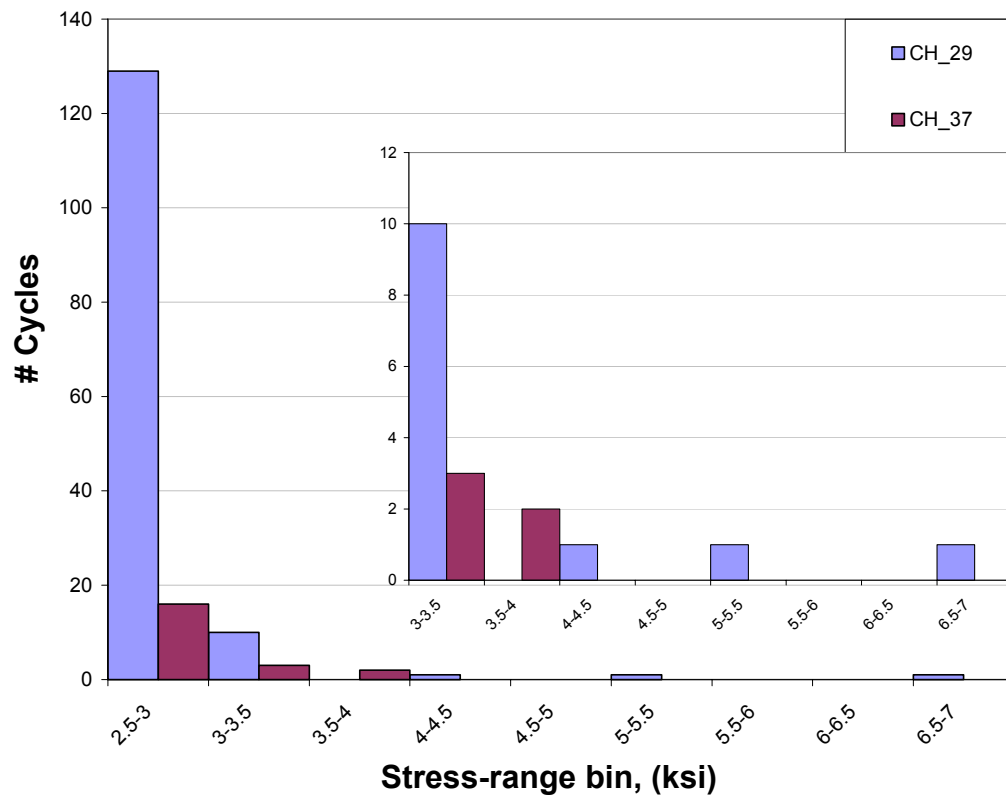
Figure 6.7 – Stress-range histogram for strain gages CH_29 and CH_27 installed longitudinally on the bottom face of the deck plate at 1 1/2" from the south termination of the north shear connector's weld in Span 34 and Span 45, respectively

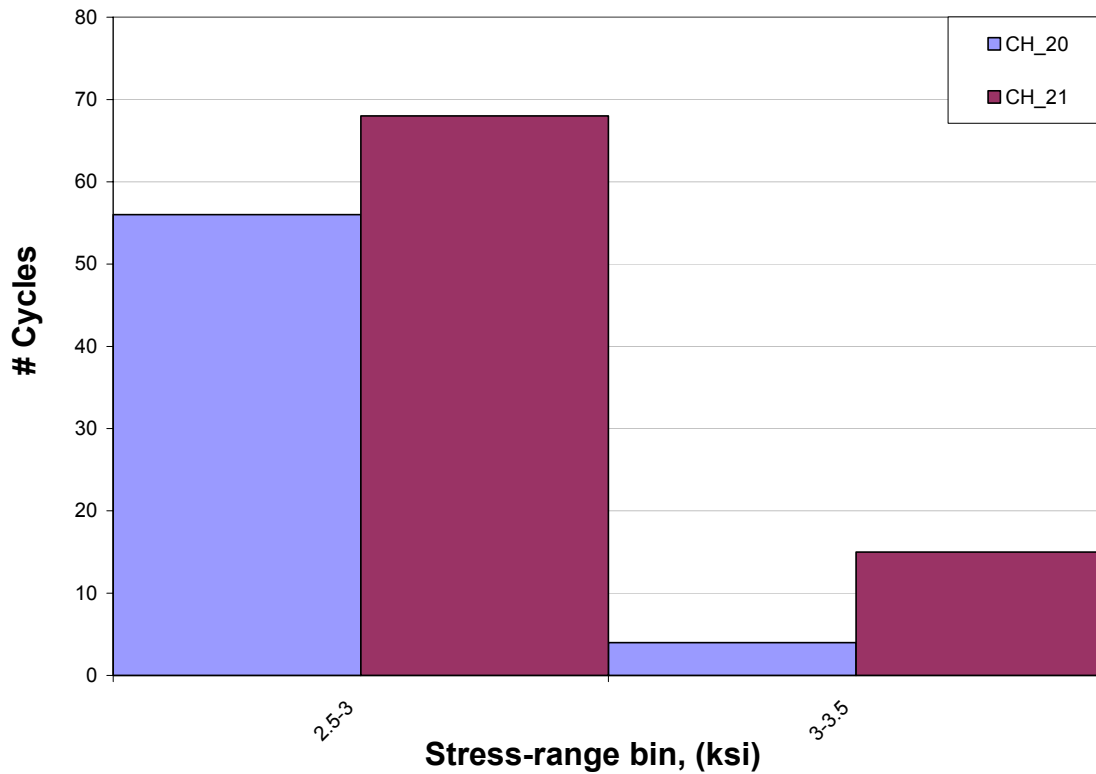
The top flange welded detail can be classified as category C detail per AASHTO Specifications, while the bottom flange bolted cover plate detail can be classified as Category B detail. Figure 6.7 presents the stress-range histogram for strain gages CH_20 and CH_21 installed on the top flange of new Sub-floorbeam 2 in Span 36. As the figure shows, low stress-range cycles were measured by both gages during long-term monitoring. A summary of the fatigue life calculations for all the above mentioned gages is presented in Table 6.8. As shown in the table, infinite fatigue life is estimated for all instrumented top flange welded new sub-floorbeam and bottom flange bolted new sub-floorbeam.

Figure 6.8 – Stress-range histogram for strain gages CH_20 and CH_21 installed in Span 36 on the top flange of new sub-Floorbeam 8 and on the west and east, respectively, of the web of Stringer 3 and near the south end of the flange edge at 1 in from the toe of the weld used for attaching the web and the flange of the build-up T-section and at 1 in from the edge of the reduced section of the flange

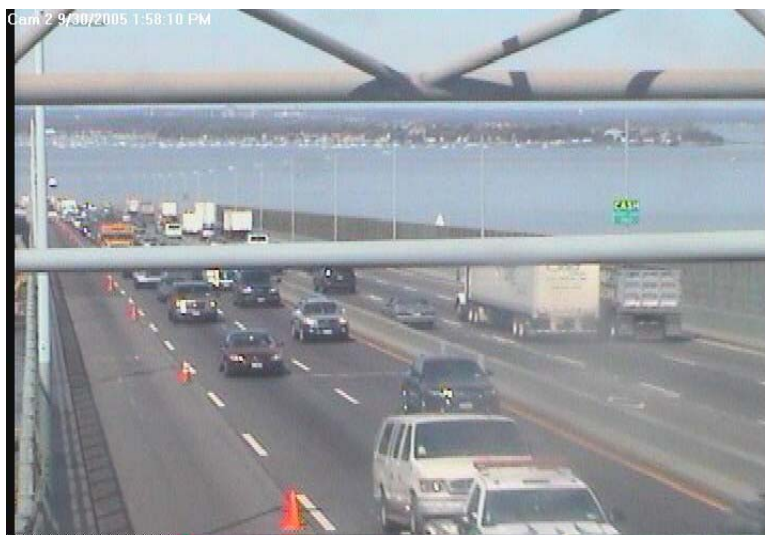
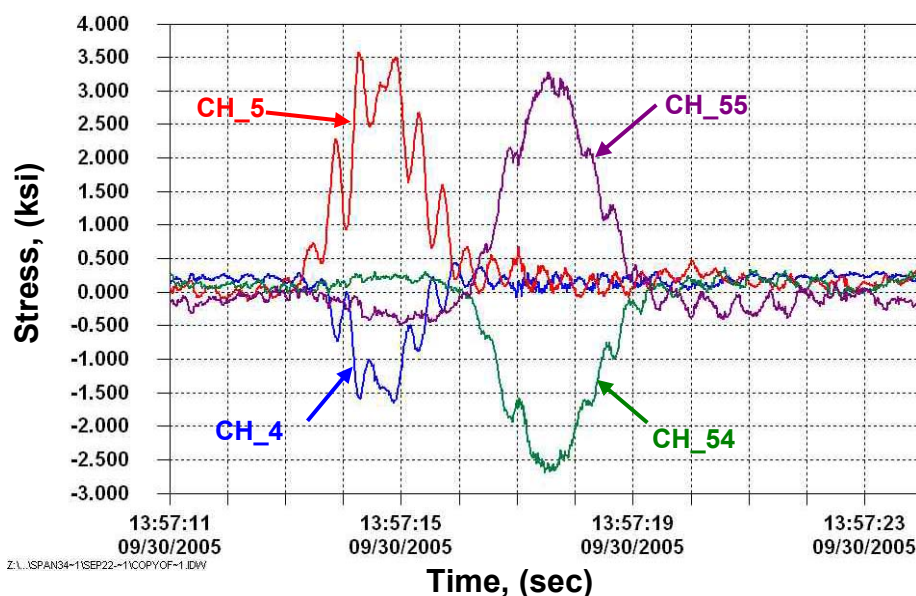
Figure D.21 – Images of 6 and 5-axle trucks traveling in the outside and middle lane, respectively, in the northbound direction on September 30, 2005 at 1:57:22 PM and the corresponding response of the gages installed on the top and bottom flange of the east girder in Span 34 and Span 35

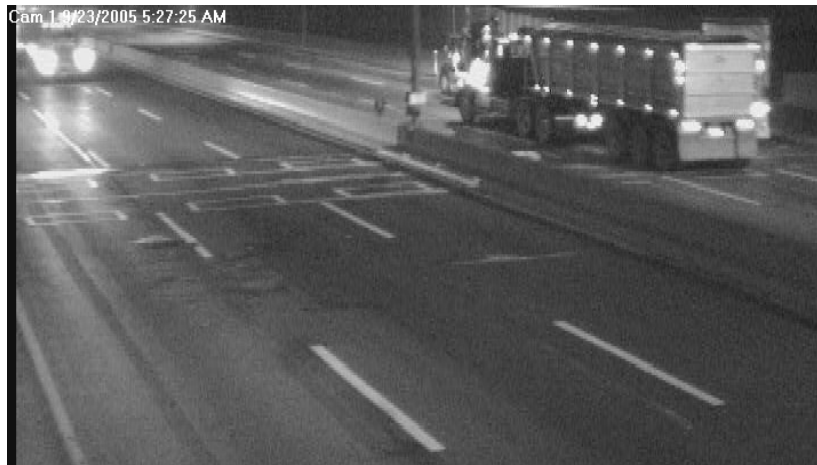
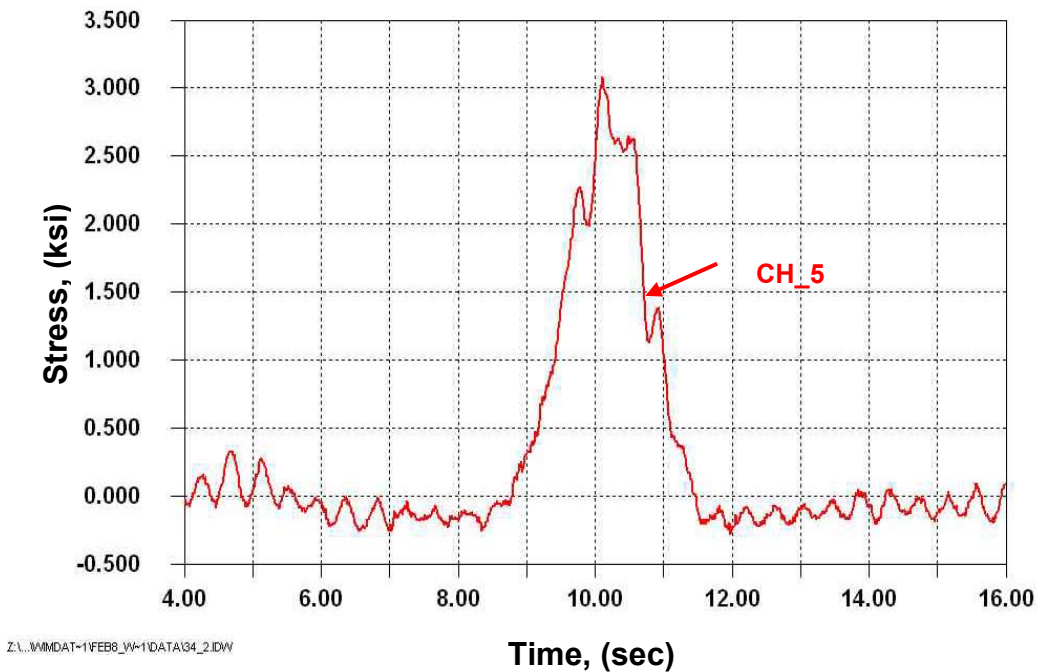
Figure D.22 – Images of 6-axle trucks traveling side-by-side in the outside and middle lane, respectively, in the northbound direction on September 23, 2005 at 5:27:01 AM and the corresponding response of strain gage CH_5 installed on the bottom flange of the east girder in Span 34

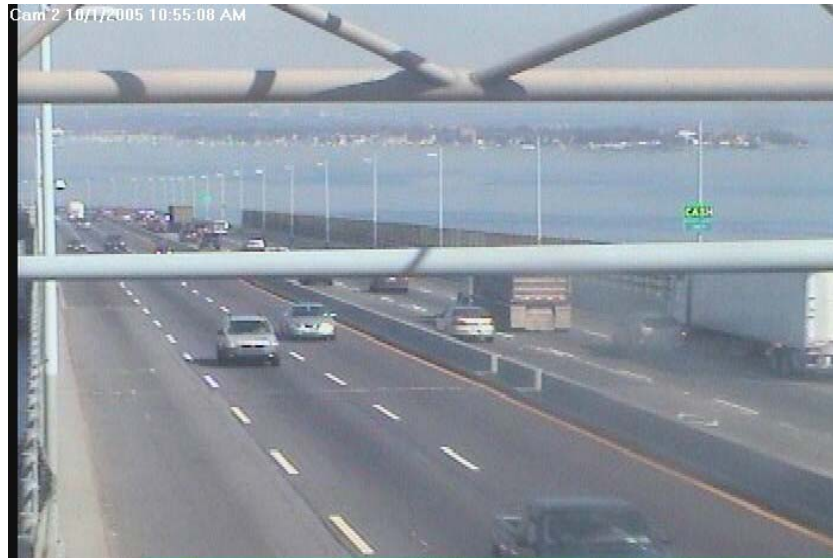
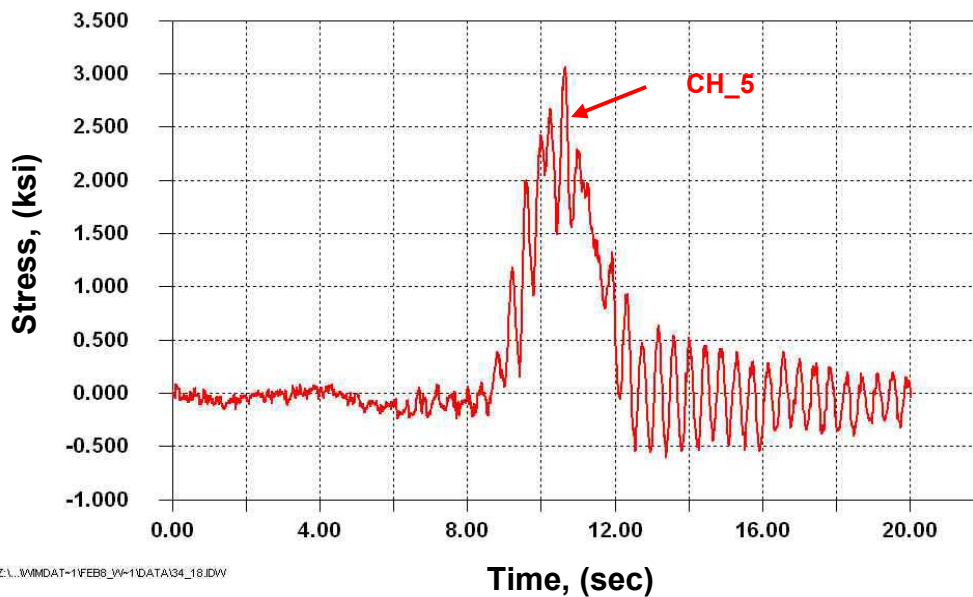
It is important to note that the stress-range histograms developed during the week of WIM monitoring shows that approximately 100 events were recorded for an average stress range of approximately 3.25 ksi. This is an average stress range, not the peak magnitude of stress as noted above. As shown in Figure D.23 the girder vibrated as it

responded to the moving of the trucks resulting in a negative response in strain gage CH_5 installed on the bottom flange and a total stress range of about 3.5 ksi. Figure D.24 shows the response of strain gage CH_5 during the controlled load test DYN2_34. The six peaks shown in the figure represent the passage of Truck 1 in the right lane (first peak), followed by Truck 2 in the same lane (second peak), followed by Truck 3 in the middle lane (third peak), followed by Truck 4 also in the middle lane (fourth peak), followed by Truck 5 in the left lane (fifth peak), and finally Truck 6 also in the left lane (sixth peak). The vibration of the east girder resulted in a compressive stress in the range of 0 – 0.25 ksi with the exception of the response of the passage of the second truck, which resulted in a compressive stress of approximately 0.6 ksi. In some cases during the random monitoring however, the magnitude of the compressive stress resulting from the vibration of the girder was on the order of 1.5 ksi as shown in Figure D.20. Such a high magnitude of compressive stress resulting from excessive vibration, which was not captured during the dynamic controlled load test, resulted in an increase in the total stress range experienced by the strain gage. Therefore, only the peak stress value of the response of the strain gage was used for correlating the random time history response with the dynamic controlled load test as explained above.

Figure D.23 – Images of 6 and 5-axle trucks traveling in the outside and middle lane, respectively, in the northbound direction on October 1, 2005 at 10:55:08 AM and the corresponding response of strain gage CH_5 installed on the bottom flange of the east girder in Span 34

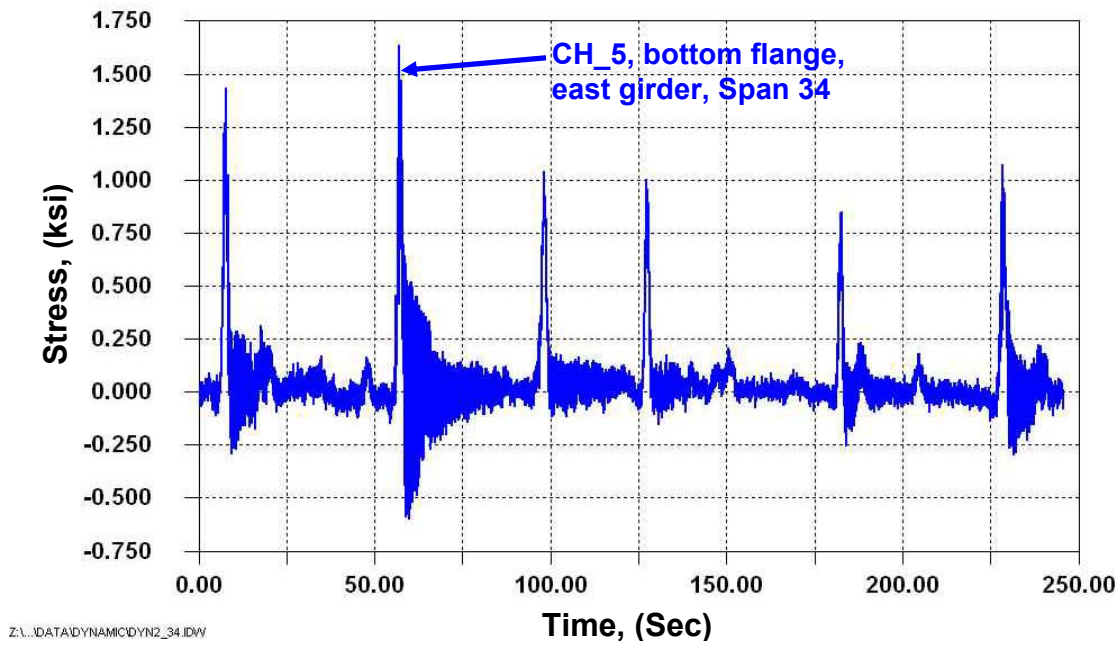
Figure D.24 – Response of strain gage CH_5 installed on the bottom flange of the east girder in Span 34, approximately 4 in north of midspan as the test trucks crossed in the northbound direction over all three lanes in the dynamic test DYN2_34
